# Evaluation of Road Complementary Building due to widening of Lilawangsa Road in Langsa City

**Abstract**— Langsa City is one of the cities in Aceh province which is doing development in all fields, especially in economy and infrastructure. Road construction and upgrading has been a priority in Langsa City, one of which is Lilawangsa road. The function of Lilawangsa road is as collector road. This road crosses two villages, Paya Bujok Tunong village and Geudubang Jawa village, Langsa Baro subdistrict, Langsa city. Road improvement is done by widening the road, causing the road shoulder no longer exists. However, this is not included with planning for support facilities, such as pavements and green belt. This is a problem especially for pedestrians, because there is no such safe and comfortable facility. The purpose of this research is to evaluate Lilawangsa road Langsa City improvement based on requirement of road section as well as arrangement of pedestrian facility and green belt. Evaluate the eligibility of road function by using road safety audit. The research method was qualitative descriptive method, based on Road Safety Audit. The result is the arrangement of the Lilawangs

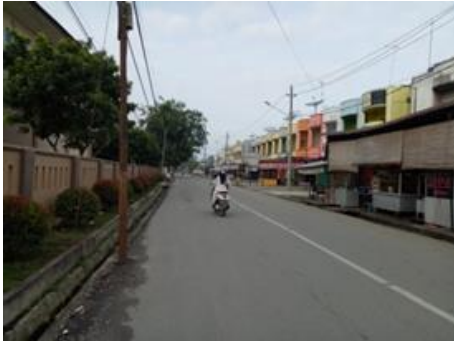
Figure 3. Condition sta.+ 0.00.

In this section, visible conditions, there are no pedestrian mall and row of shophouses along the road.

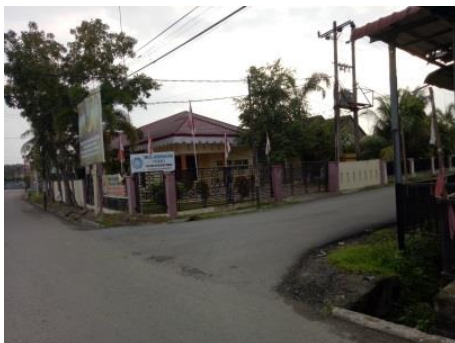
Figure 4. *geuchik Paya Bujok Tunong office.*

In Figure 4, there is still a green belt, but there is no pedestrian mall.

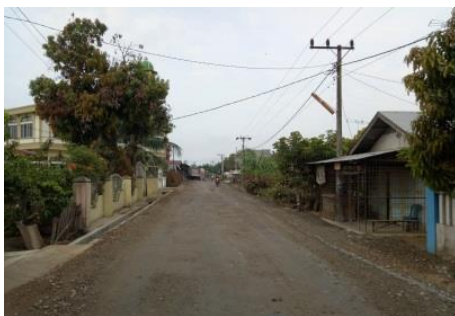
Figure 5. Drainage condition.

On this road segment already built drainage on both sides of the road, but there is a section of road that has no drain on one of the roadside.

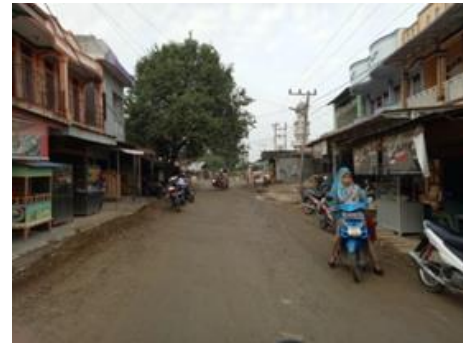
Figure 6. Parking on the traffic lane.

The unavailability of parking facilities in every building, especially shophouses, resulted in traffic lanes used for parking vehicles.

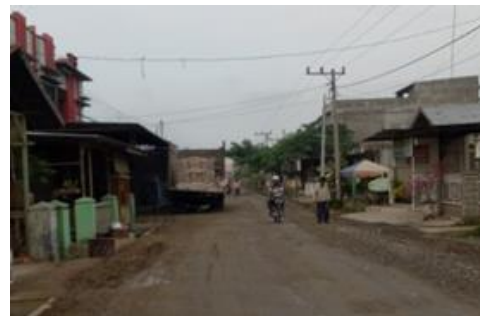
Figure 7. The condition of pedestrians.

Pedestrians walk on traffic lane. This is the effect from unavailability of pedestrian mall on the road.

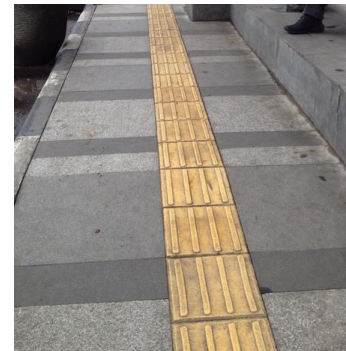
Figure 12. Material of Pedestrian Mall.

Pedestrian path material is planned to use materials that are friendly to people with disabilities, it is materials with a texture that is not slippery (surface material rough/rise). There is also a tile texture as a guide and a warning and ramp at each intersection. Pedestrian path development should avoid potentially life-threatening hazards such as rail and holes along the path..
